Convegno
Internazionale AiCARR
AiCARR International
Conference

Roma
26-27-28
Febbraio 2014

Upgrading 20th Century Historic Buildings in Accordance to Principles of Energy Efficiency

Riqualificazione energetica dell'edilizia residenziale storica del Novecento

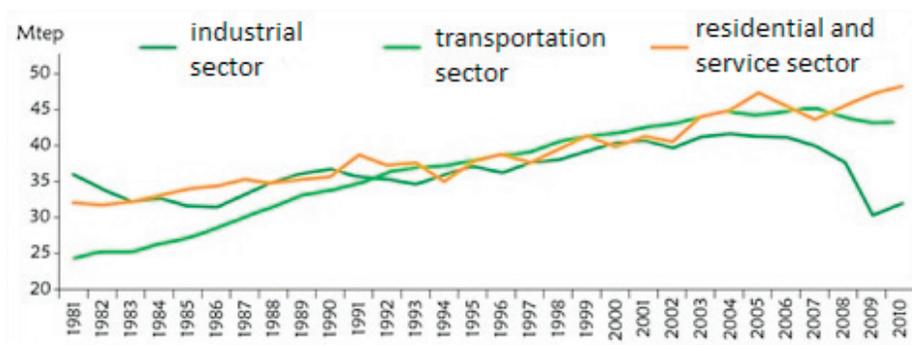
Figure 1 – Primary energy consumption per sector – Processed by CRESME on data from M.I.S.E. and ENEA

Recent statistics on energy consumption indicate that in Italy (but not only), the highest percentage of primary energy consumption is attributed to the real estate sector (residential and service sector) (Figure 1). In this sector, unlike the industrial and transportation sectors, there has been a constant rise in energy consumption consistent with data from previous years: the level of energy consumption (approx. 48 MTEP) is equal to a high level of pollution emissions.

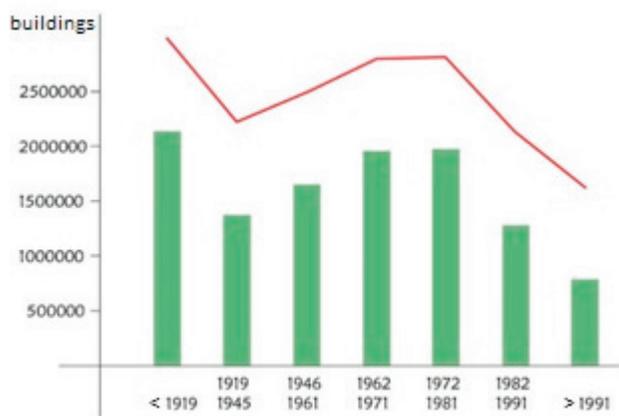
Figure 2 – Years of building property construction - Data by ISTAT Census 2001

Furthermore, most of Italy’s architectural heritage was built during the economic and real estate boom that took place during the 1960s and 1970s, (Figure 2). During this growth in building construction, politicians and public administration focused mainly on the quantity rather than the quality of construction.

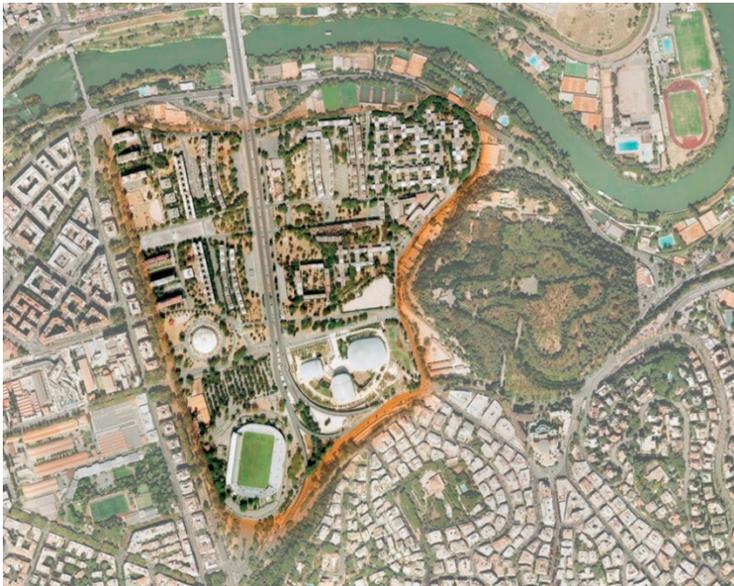
Figure 3 – Recent aerial photograph of the Olympic Village in Rome

The Olympic Village (Figure 3) was built in 1958-59 for the XVII Olympic Games held in Rome in 1960. The site chosen was along the plain between the Villa Glori Hill and the Tiber River, an area owned by the city that had been designated for residential building after World War II.

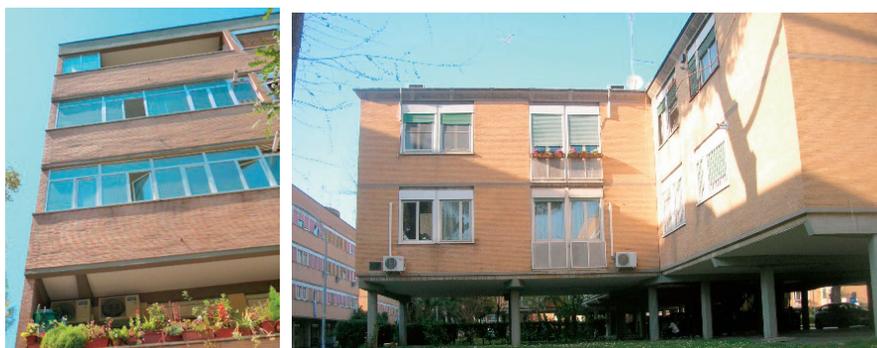
Figure 4 – Closed off balconies with different types of windows (left) and the addition of air conditioners

Closing off the balconies to acquire extra living space (Figure 4); the use of different kinds of shades for protection against harsh sunlight; changing the colours and materials of the window blinds; installing different types of independent heating systems, and external air conditioning units are the most common elements that “disturb” the façade. Additional modifications include elevators in the stairwells, painting the *pilotis* and changing the floor plans of the apartments.

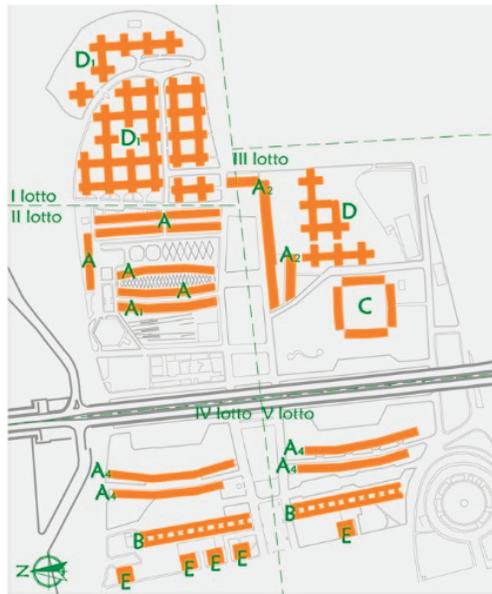
Figure 5 – Olympic Village in Rome: separated by type

In the hypothesis of an energy efficient renovation, it is necessary to take into consideration the various types of buildings characteristic to the neighbourhood, and find technical solutions suitable for the upgrade interventions in each specific situation. For example, the possibility of installing solar power and/or photovoltaic power supply must be adapted and divided according to the five building types (Figure 5), and interventions that are or are not feasible and effective in preserving the value of the buildings must be identified.

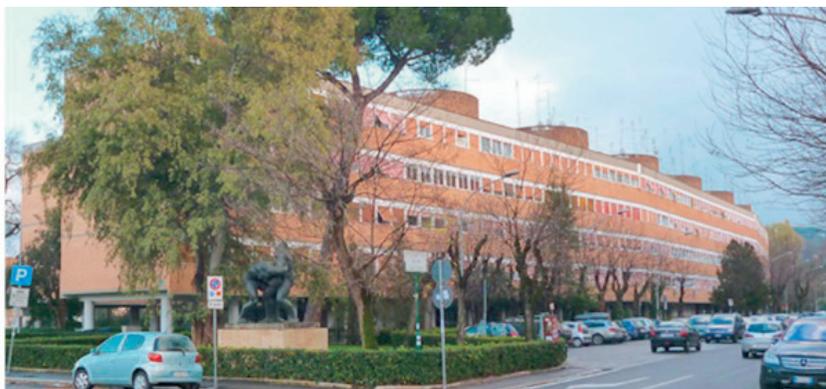
Figure 6 – Building via Unione Sovietica

In order to quantify the positive effects of feasible interventions, a standard building type was studied (Figure 6). The structure is 150 metres long, 10 metres wide and has a north-south exposure. The building has a load-bearing structure in reinforced concrete; it is five storeys high, elevated “on *pilotis*” and features eight stairwells which did not originally house elevators. Each stairwell serves two apartments (with double orientation) per floor, for a total of 64 apartments with floor space ranging from 80 to 90 m².

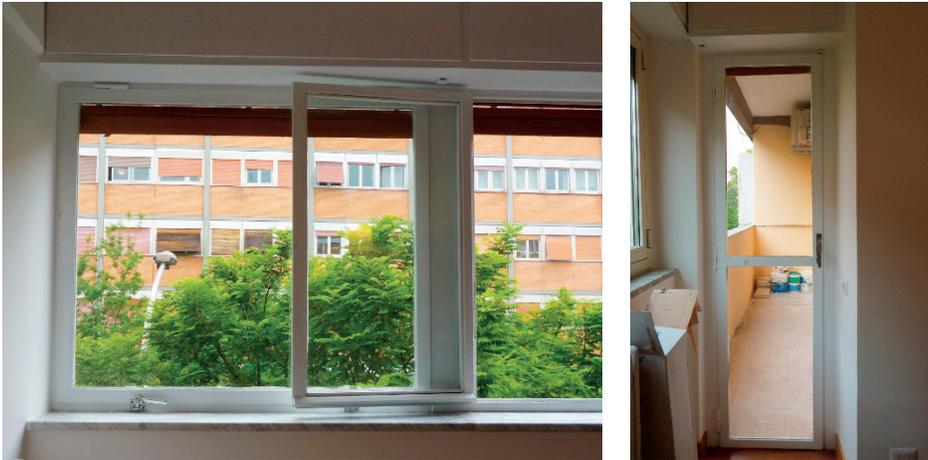
Figure 7 – Examples of windows

The original windows, some of which are still *in situ*, are made of ready-made self-contained systems in zinc-coated steel, painted white. The frames are very thin, without glazing, and the glass is only 2 millimetres thick. The long ribbon windows on the west side are double-leaf or bottom-pivoting hopper casement (figure 7) that alternate and form repetitive three-unit modules along the entire façade. The façade facing east is characterized by one or two-leafed panels, and one or two-leafed French doors (Figure 7) that open onto the balconies.

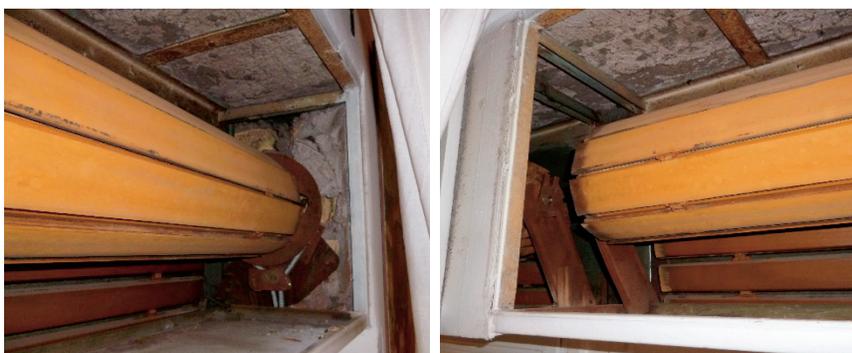
Figure 8 – Detail of the box and roll-down blinds

Every window has roll-down blinds that were originally made of yellow painted wood. They are housed in zinc-coated steel blind boxes and secured directly to the reinforced concrete curb without insulation (Figure 8).

Regarding the original windows on the west facing side, it is necessary to insulate the blind boxes using two isolating sheets that adjust to the existing structure ($U= 0,6 \text{ W/m}^2\text{K}$). Furthermore, according to the solutions, double paned windows in wood replace the windows facing east with the same thickness as the existing ones, and with improved performance, $U= 1,5\div 1,8 \text{ W/m}^2\text{K}$, $g = 0,59$.

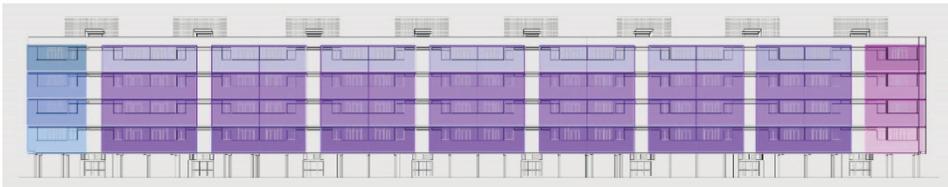
Figure 9 – Division of apartments by position and exposure (south: on the left, east-west: in the middle, north: on the right)

In view of these aspects, the table below illustrates various phases of intervention where each individual case can choose the intervention that best meets its needs, and will not have an impact on the historic and architectural value of the building (Figure 9, Table 3) (Mancini F., Caruso G., Ceci A., 2010).

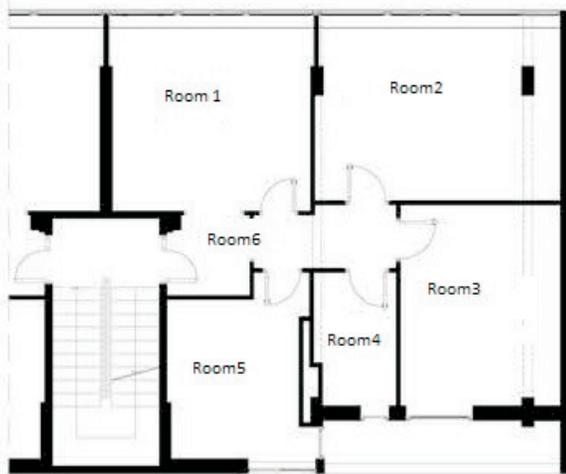
Figure 10 – Plan of the apartment

Regarding the installed systems, the intervention proposes the replacement of the gas heaters with a aérothermal heat pump (Table 4), radiant heating floor panels, fan coil units (integrated where necessary), and an accumulator tank for domestic use of hot water. This would result in using renewable aérothermal resources in compliance with Legislative Decree 28/2011. An additional improvement that would lead to an even higher energy classification, but is not foreseen in the guidelines for this specific case, is the installation of photovoltaic panels on the roof.
